RAHWAY RIVER BASIN
RAHWAY RIVER WEST BRANCH
ESSEX COUNTY,
NEW JERSEY

ORANGE RESERVOIR DAM

NJ 00361

PHASE 1 INSPECTION REPORT NATIONAL DAM SAFETY PROGRAM

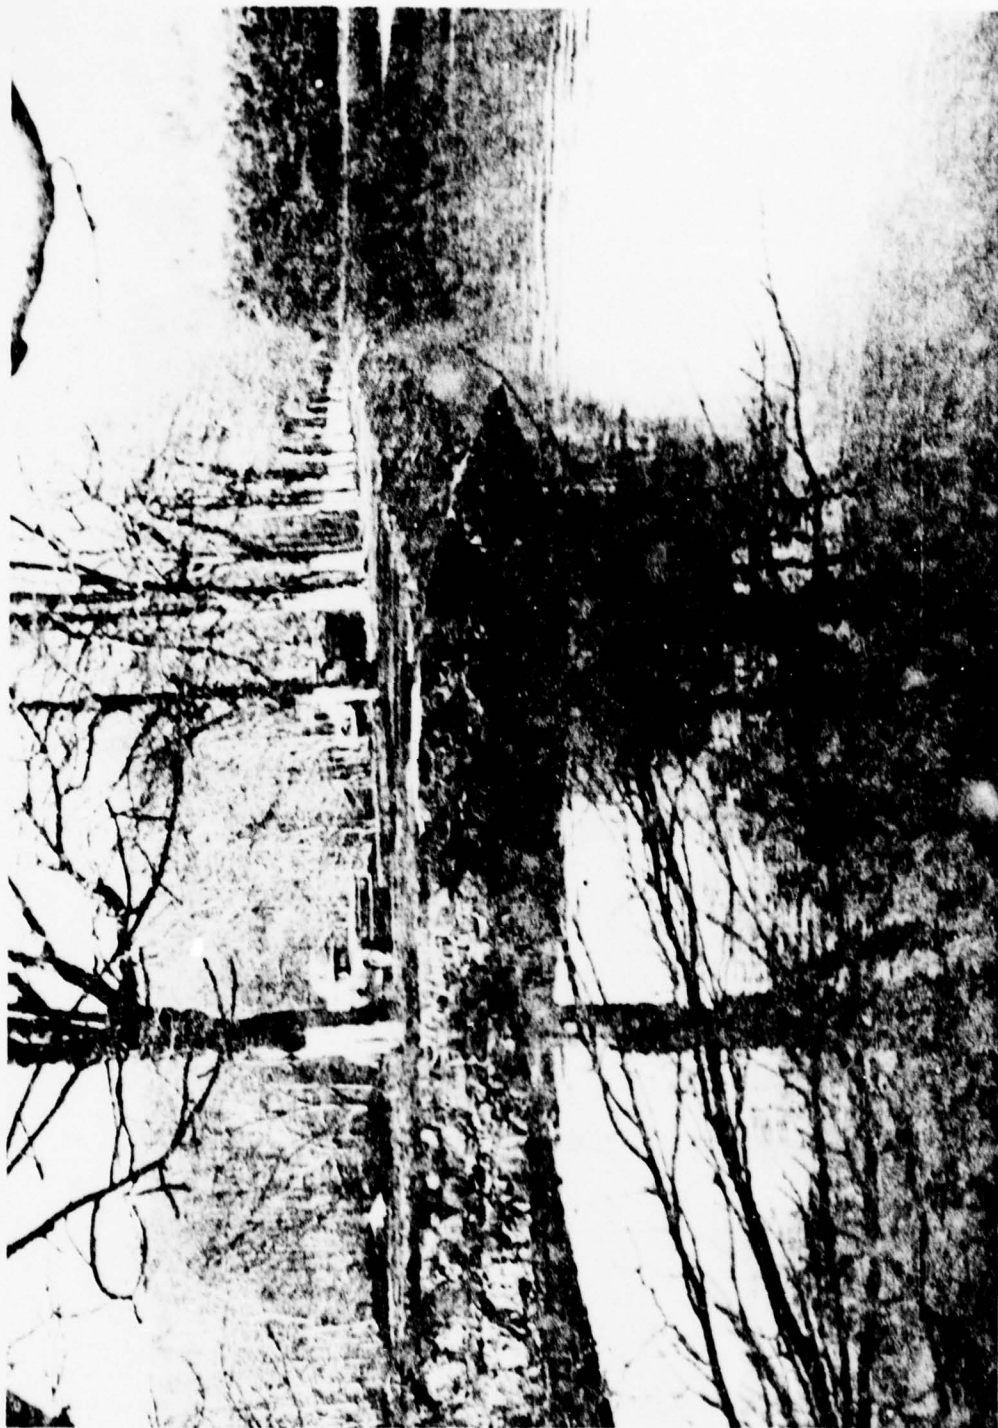
View of dam from left abutment with spillway in foreground. (Dec. 2, 1978)

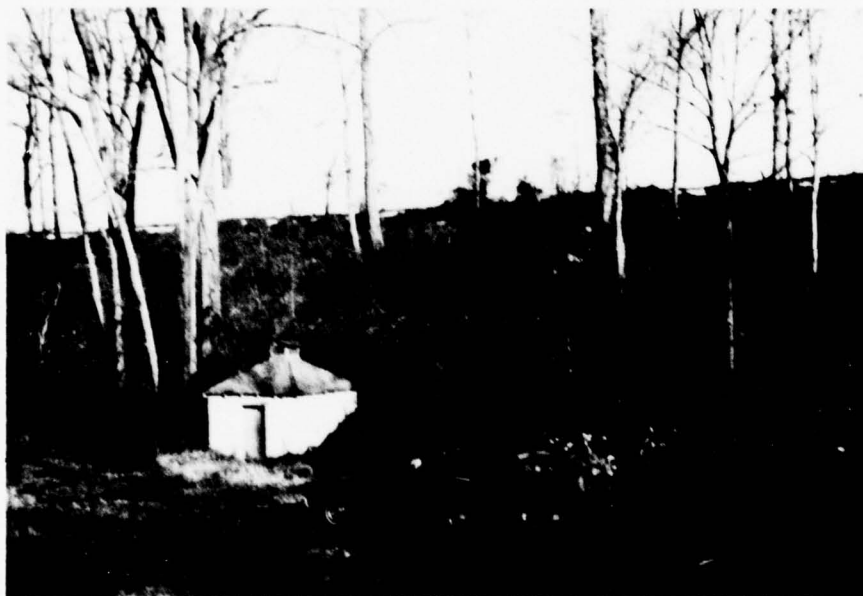
Photo 1 - View showing central section of the downstream face of dam.

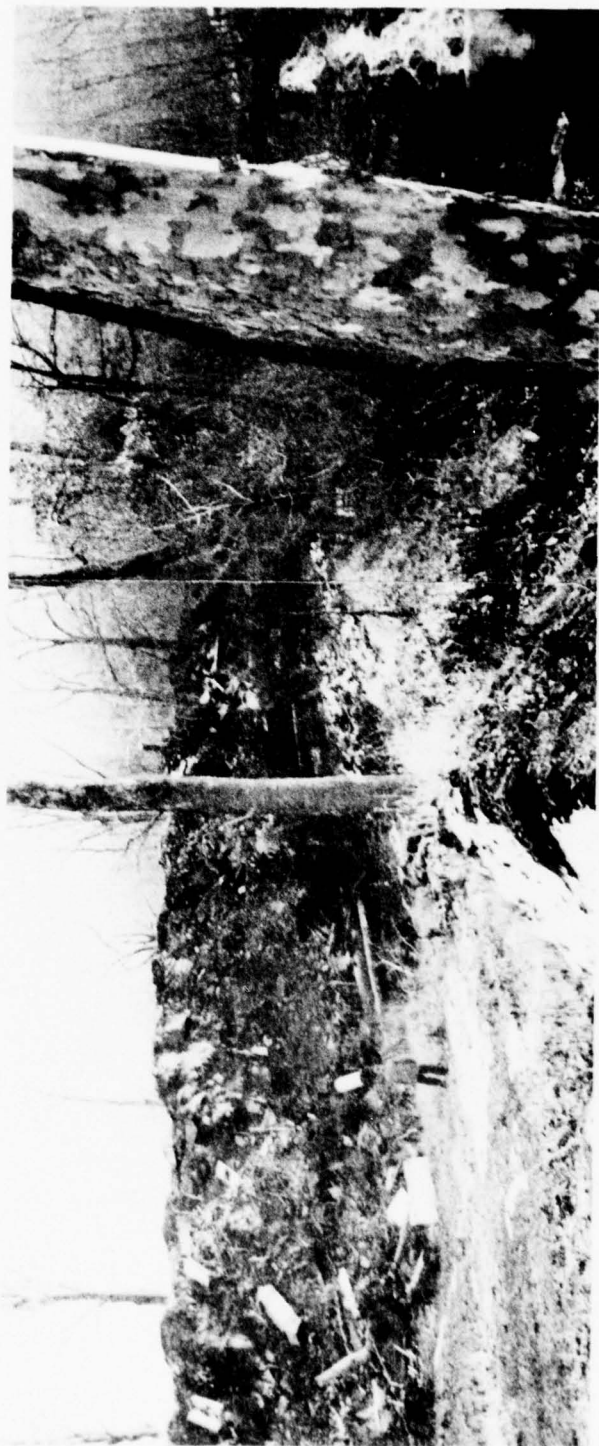
Photo 2 - View looking towards the downstream left abutment of dam showing mixed fill, spillway diversion dike and spillway channel.

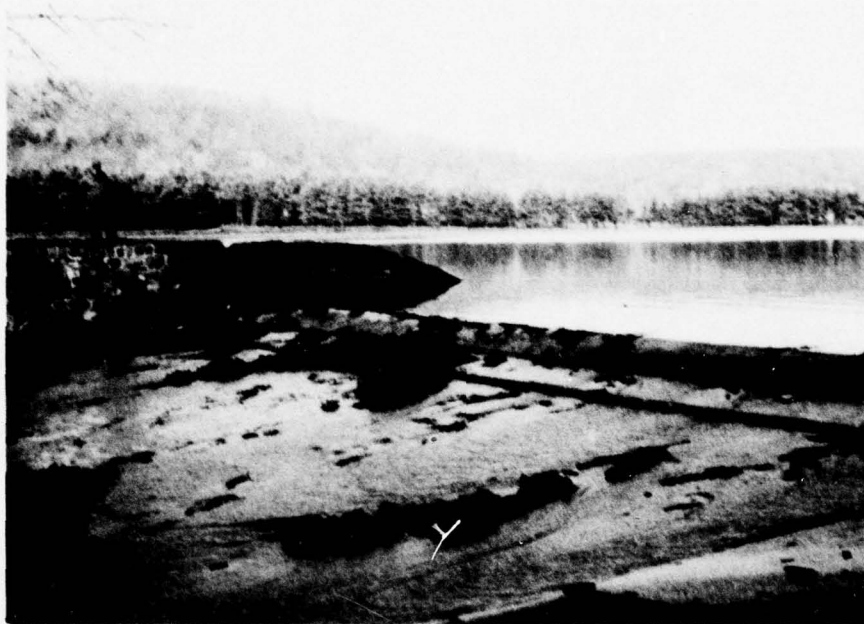
(3) Stones dislodged from the upstream end of the right spillway wing wall should be replaced.

Photo 3 - View of spillway and right wing wall looking northwest.

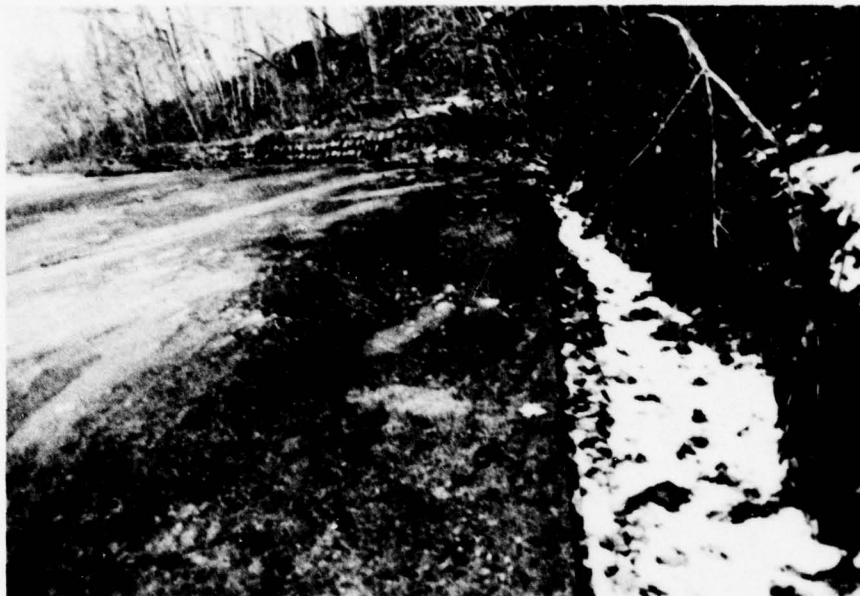
holes are present in the spillway wing walls, but no flow was observed. Minor erosion of the left abutment has occurred adjacent to the concrete apron, downstream of the wing wall (Photo 5).

Photo 5 - View of left abutment from downstream spillway apron.

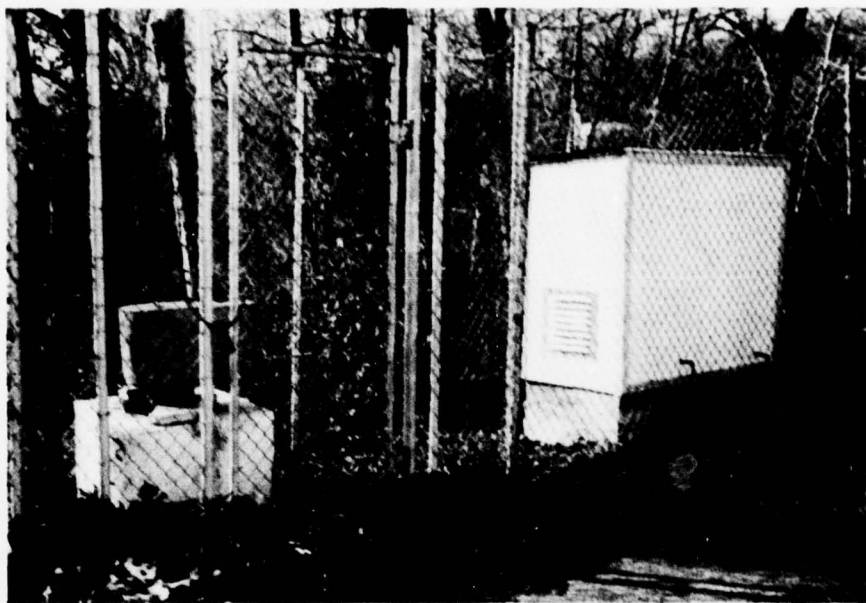
Photo 7 - View showing tunnel vent (left) and aerator compressor (right) at crest of dam.

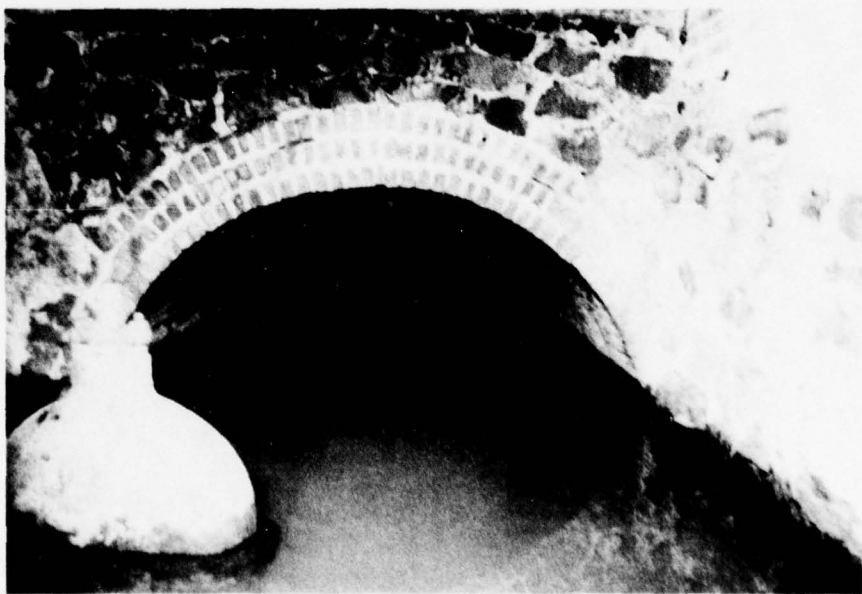
The two outlet pipes were observed inside a 9-foot diameter brick and masonry tunnel, along with associated gate valves (Photo 8). These pipes are submerged in water about 2 feet deep. Water dripping slowly in the tunnel was heard during the inspection; however, the visible section of the tunnel appears to be in good condition. An air vent for the tunnel exits at the crest of the dam (Photo 7).

Photo 8 - View of outlet pipes (submerged).

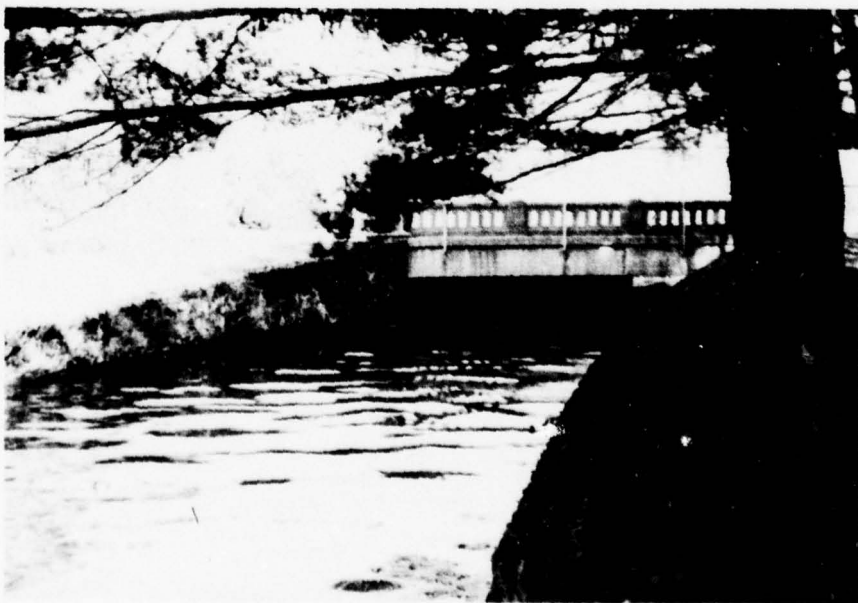
Photo 10 - View of Northfield Road bridge looking upstream.

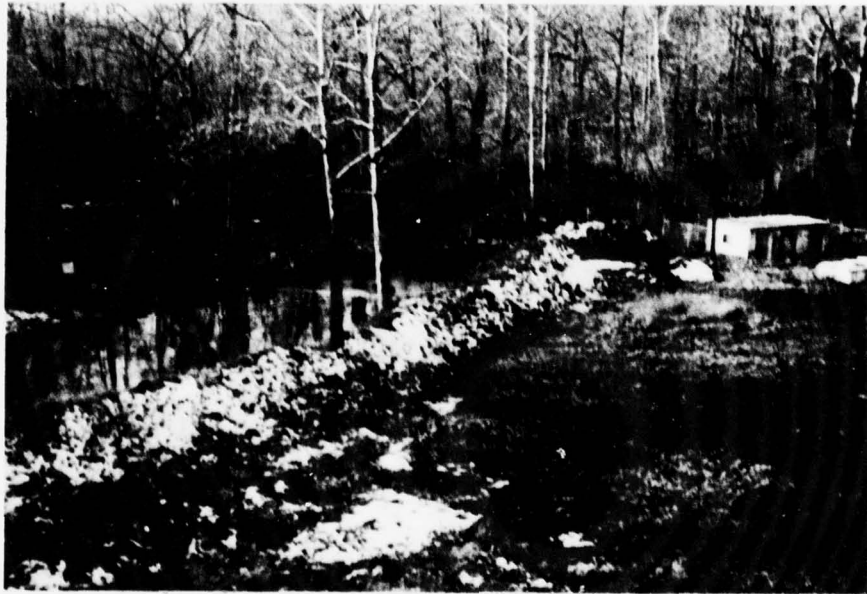
to three feet deep with a levee on the right bank about seven feet high. No dwellings were observed immediately downstream. The flood plane below the dam contains a fairly dense stand of medium and small trees with significant undergrowth (Photo 11).

Photo 11 - View looking downstream from left (east)
side of dam.
